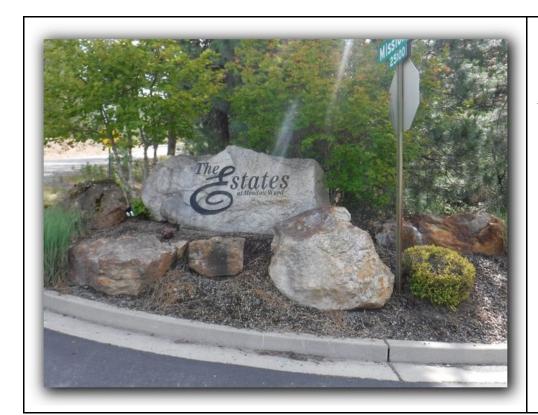
1

Entry monument

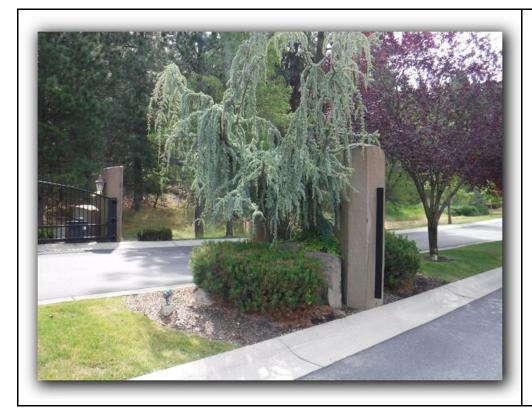
2

Exit gate and support

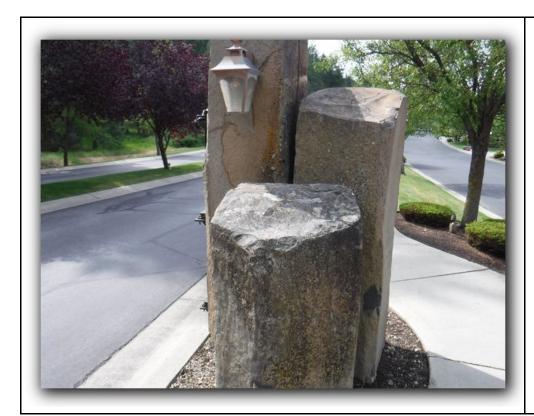
3

Entry gate support

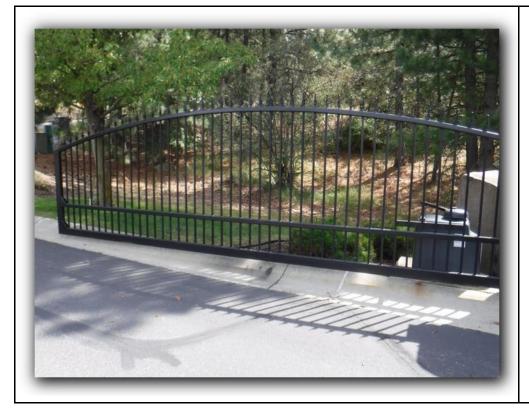
4

Exit gate

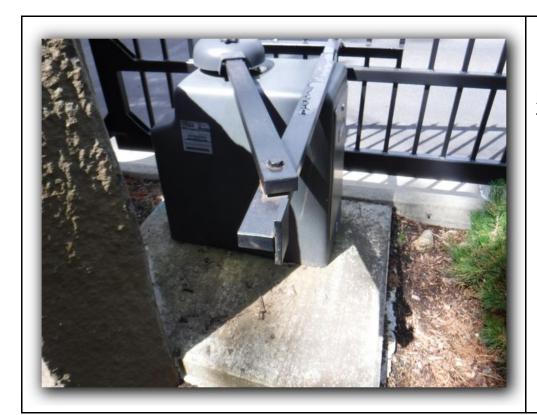
5

Typical gate operator

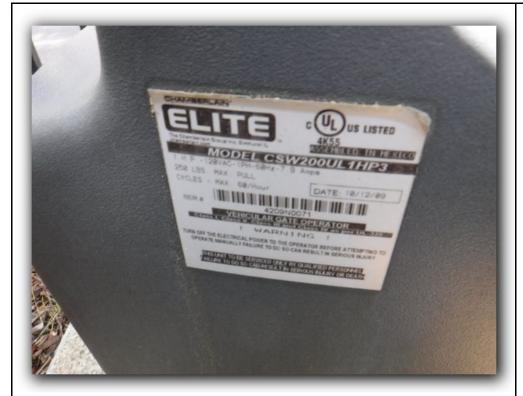
6

Gate operator label

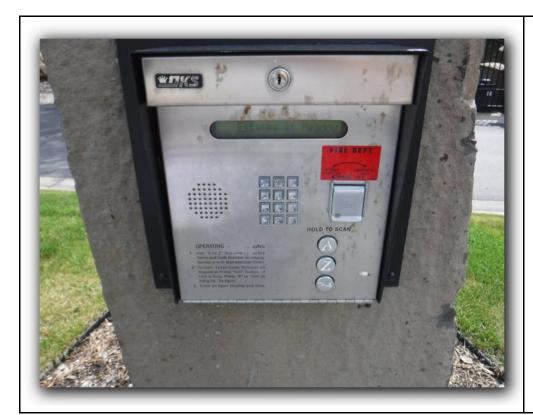
<u>Description</u>: Keypad gate controller

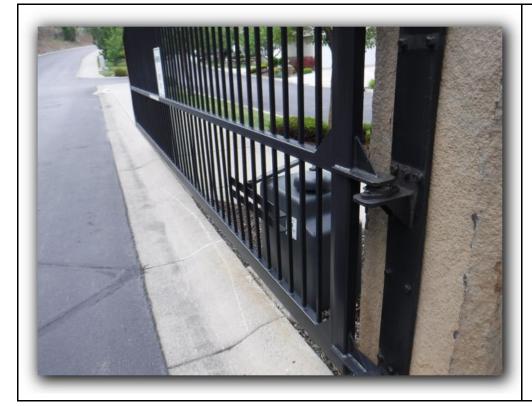
8

<u>Description</u>: Entry gate

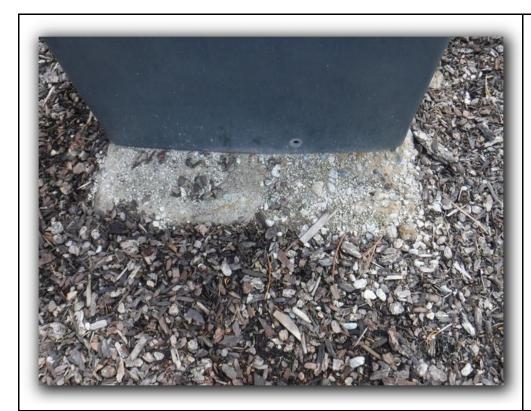
9

Entry gate concrete pad deterioration

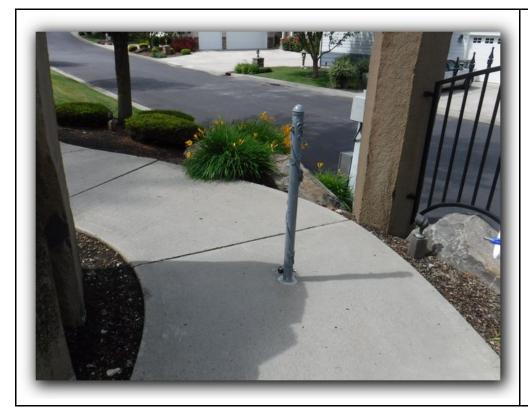
10

Pedestrian entry

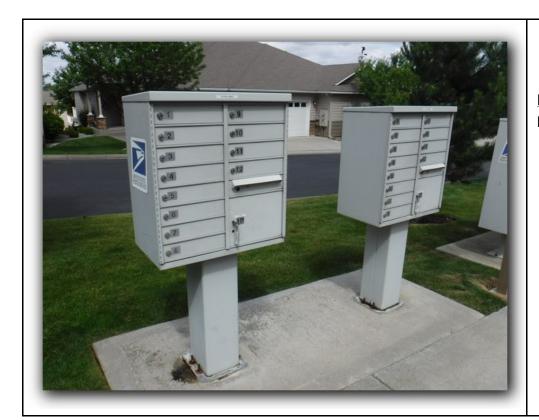
<u>Description</u>: Mailboxes

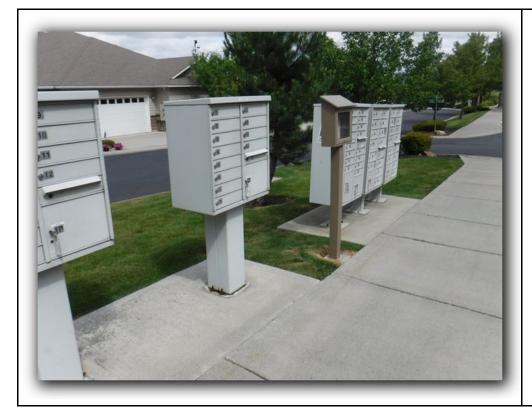
**12**

<u>Description</u>: Mailboxes

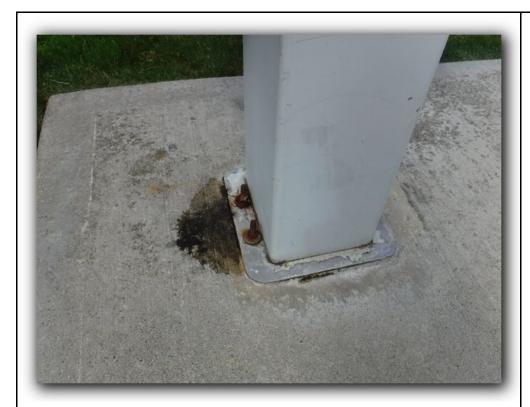
<u>Description</u>: Corroding anchor bolts on mailbox base

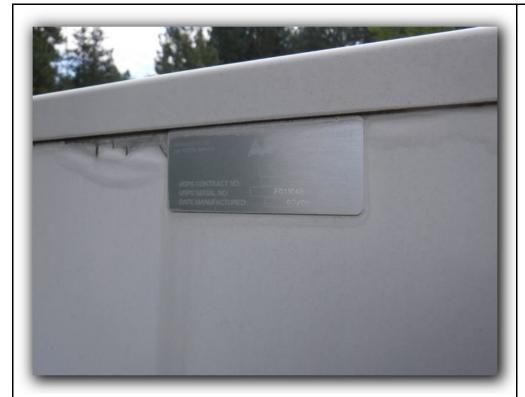
Photo Number **14**

<u>Description</u>: Mailbox label

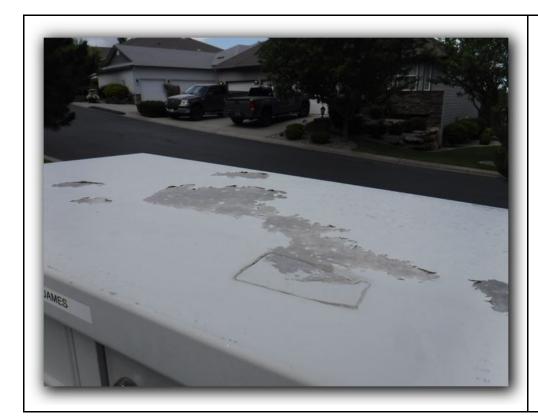
<u>Description</u>: Peeling mailbox paint

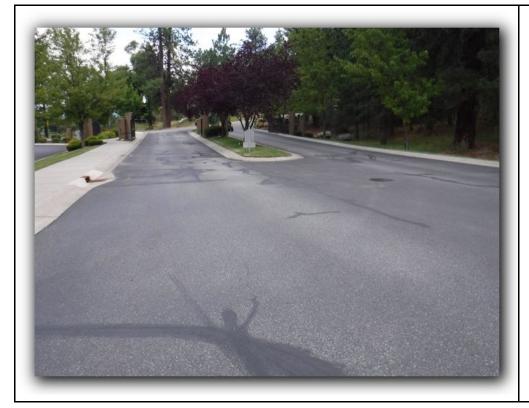
Photo Number **16**

<u>Description</u>: View toward entry

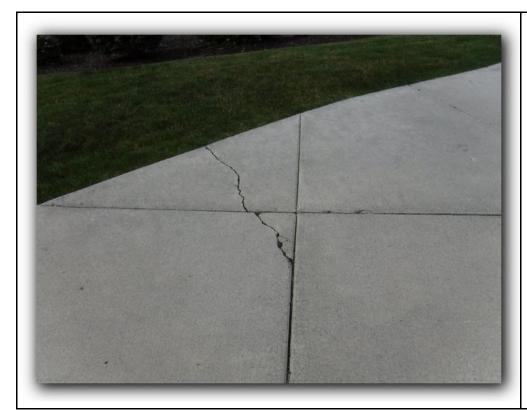
<u>Description</u>: Cracked sidewalk near entry

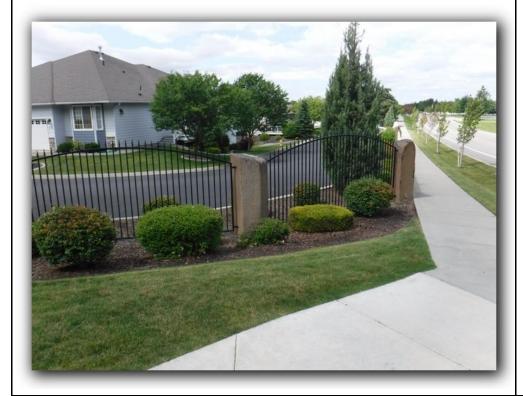
Photo Number **18**

Steel and stone fence at entry

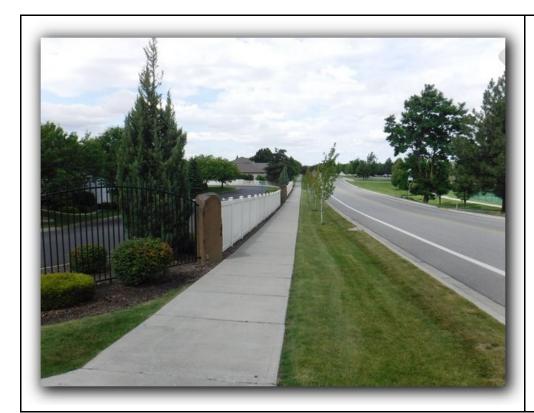
<u>Description</u>: Vinyl fence and sidewalk along Mission St.

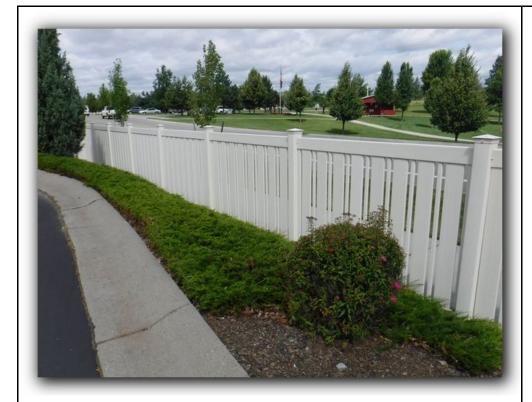
Photo Number **20**

<u>Description</u>: Vinyl fence

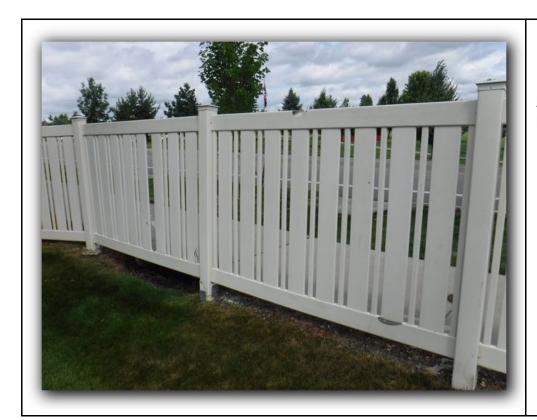
Damaged area of vinyl fence

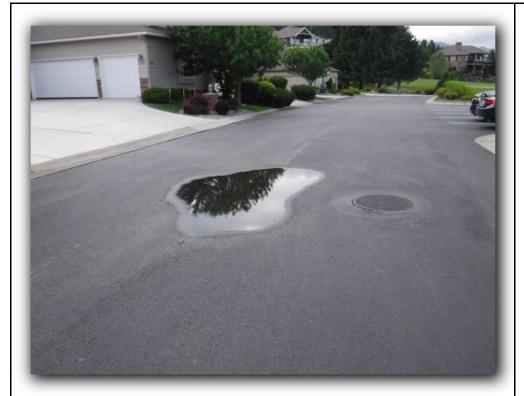
Photo Number **22**

Ponding water on Terrace Lane

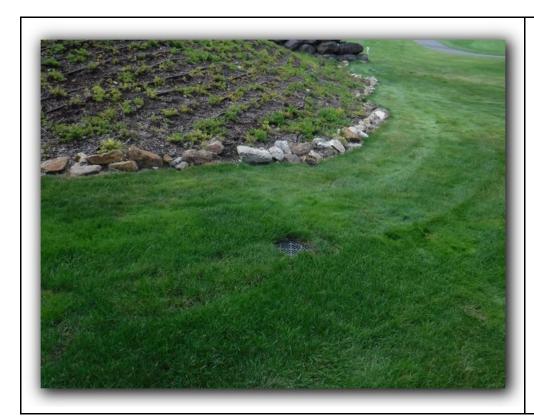
<u>Description</u>: Area of excessive moisture

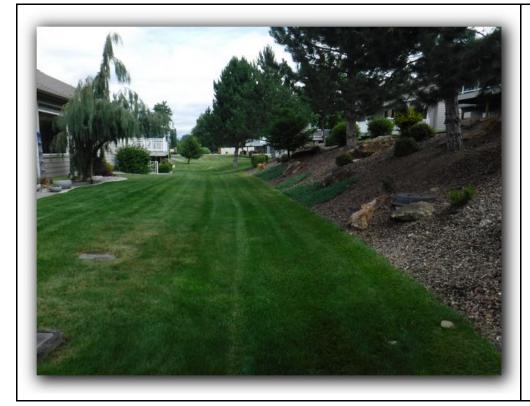
Photo Number **24**

Lower common area swale

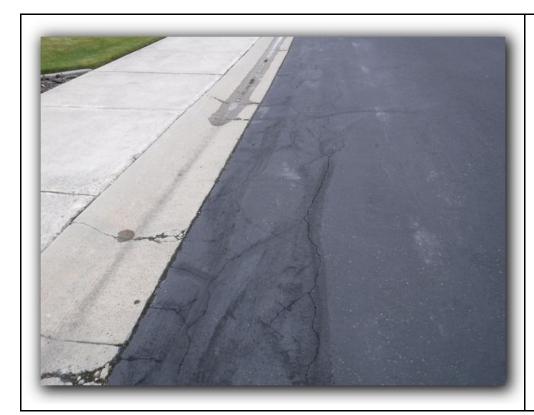
<u>Description</u>: Broken asphalt and fine cracks

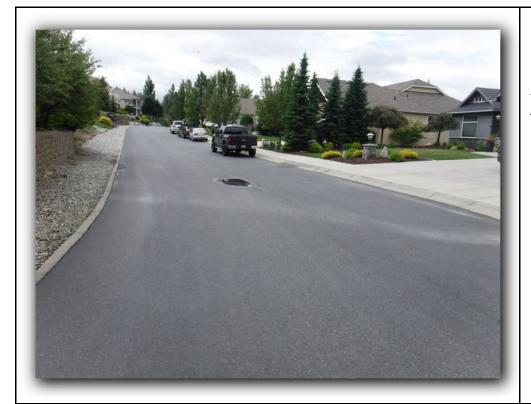
Photo Number **26**

<u>Description</u>: Area of ponding

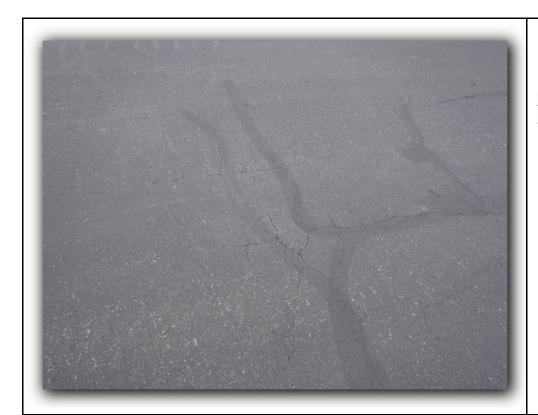
<u>Description</u>: Small broken asphalt area

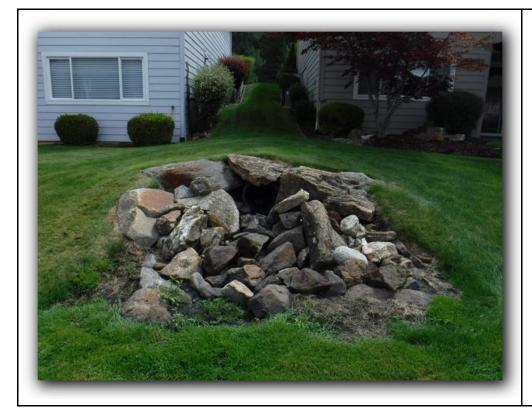
Photo Number **28**

<u>Description</u>: Runoff drain

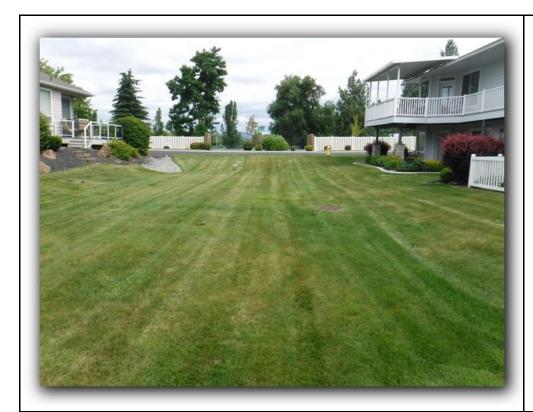
Lower common drainage area

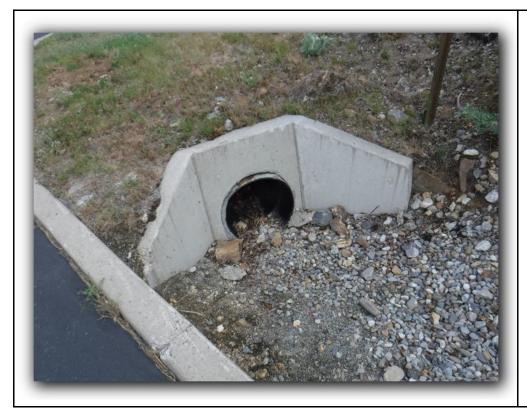
30

Runoff drain with stones inside
