Spokane, Washington

Photos Taken by:
Kenneth Pfaff

Inspection Date:
March 10, 2022

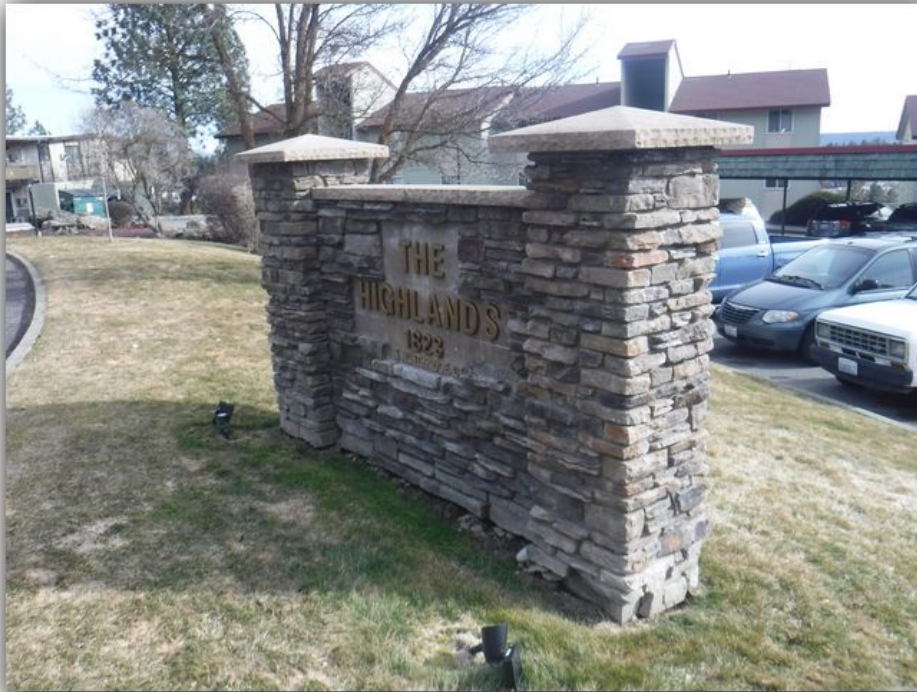
1

Entry monument

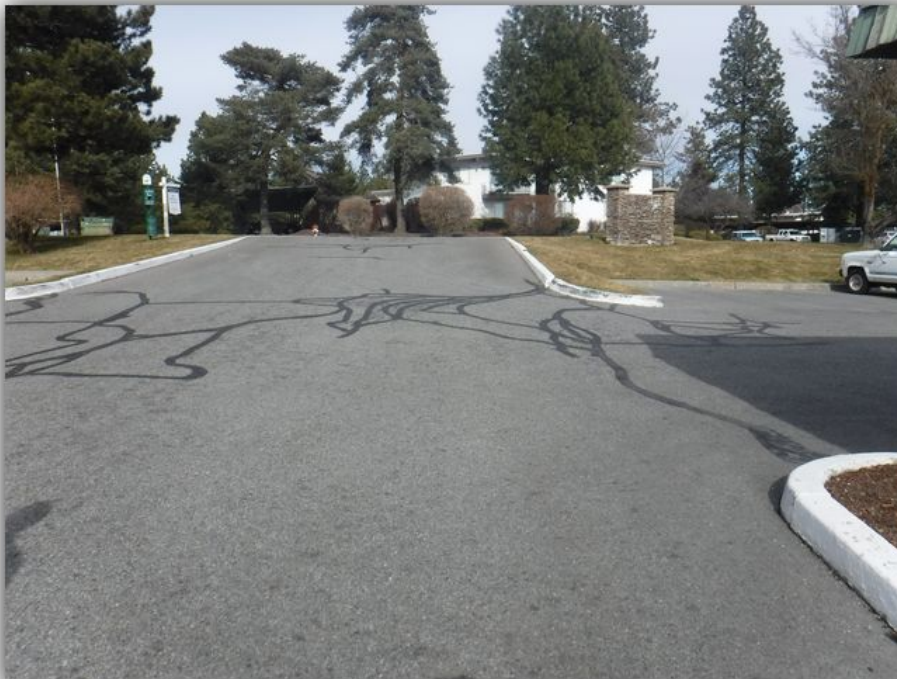
2

Asphalt at entry, small broken up area

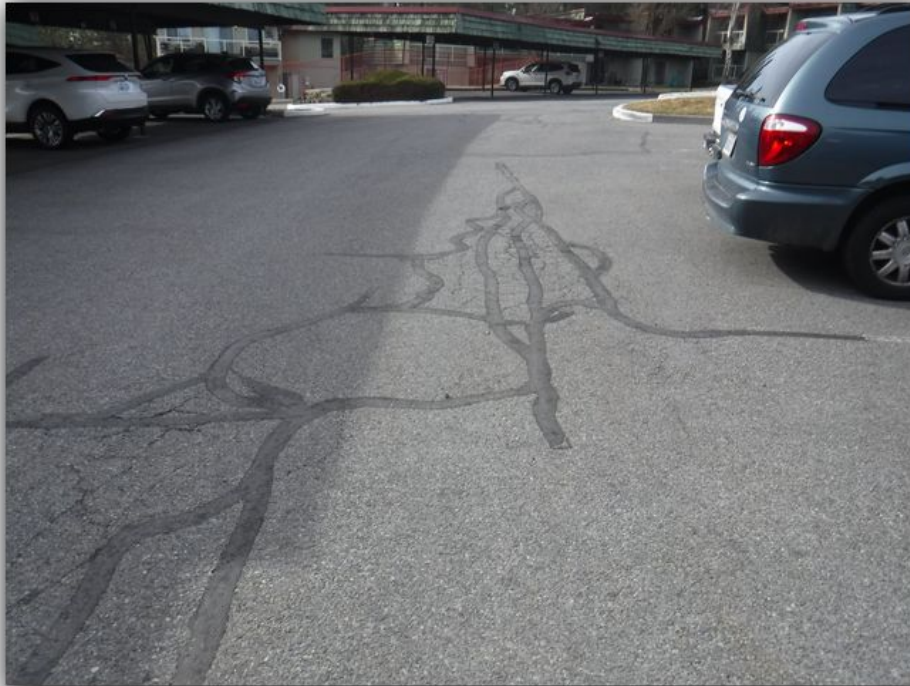
3

Driveway, small broken up areas

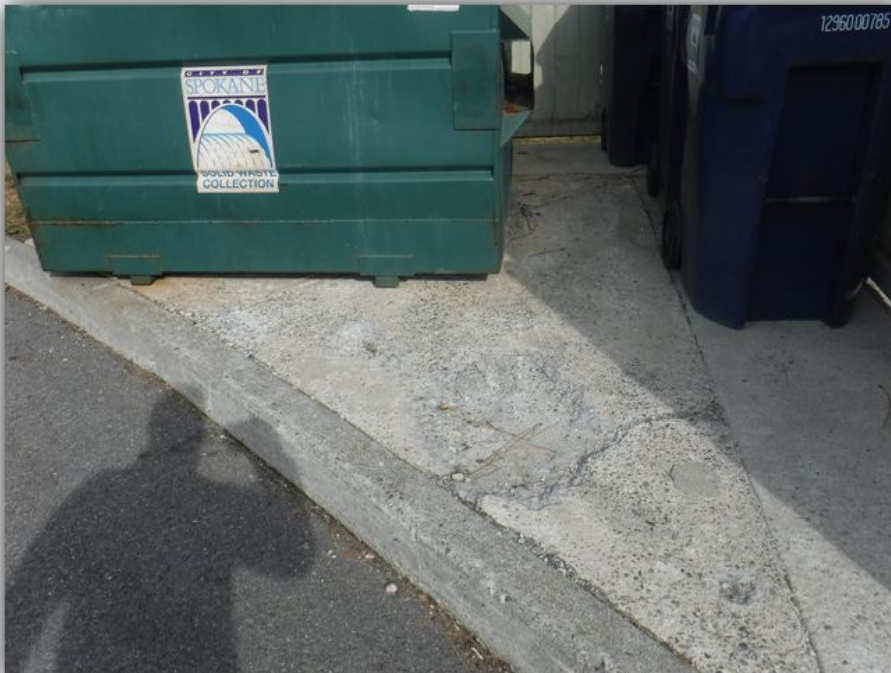
4

Dumpster pad deterioration

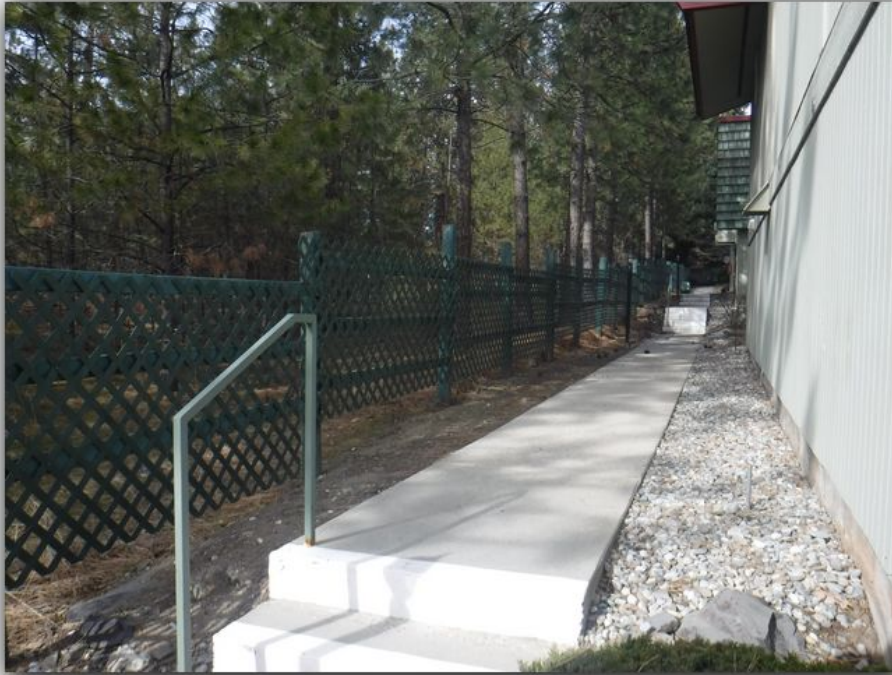
5

Wood fence

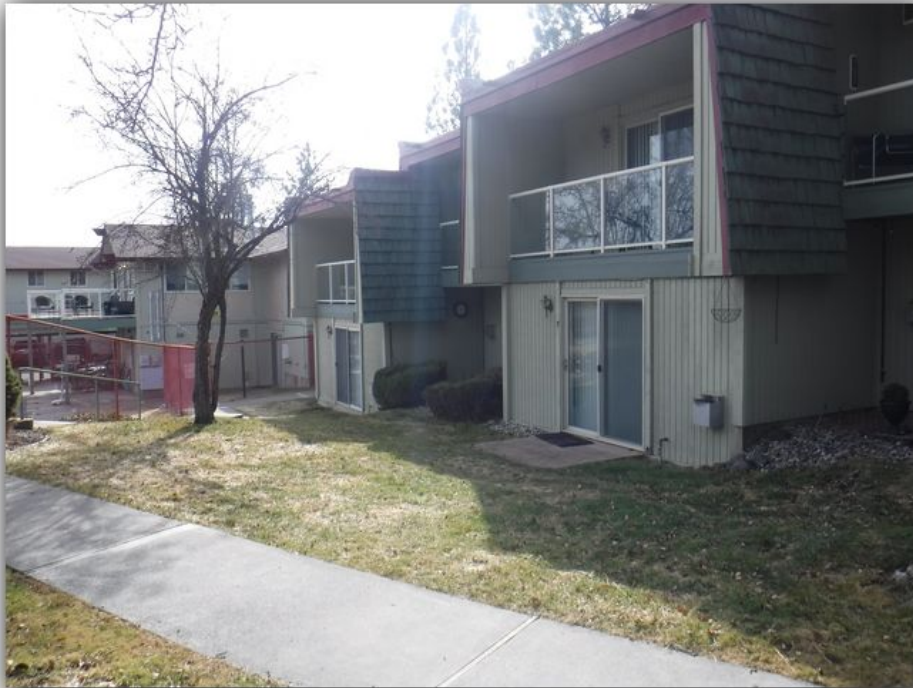
6

Townhouses

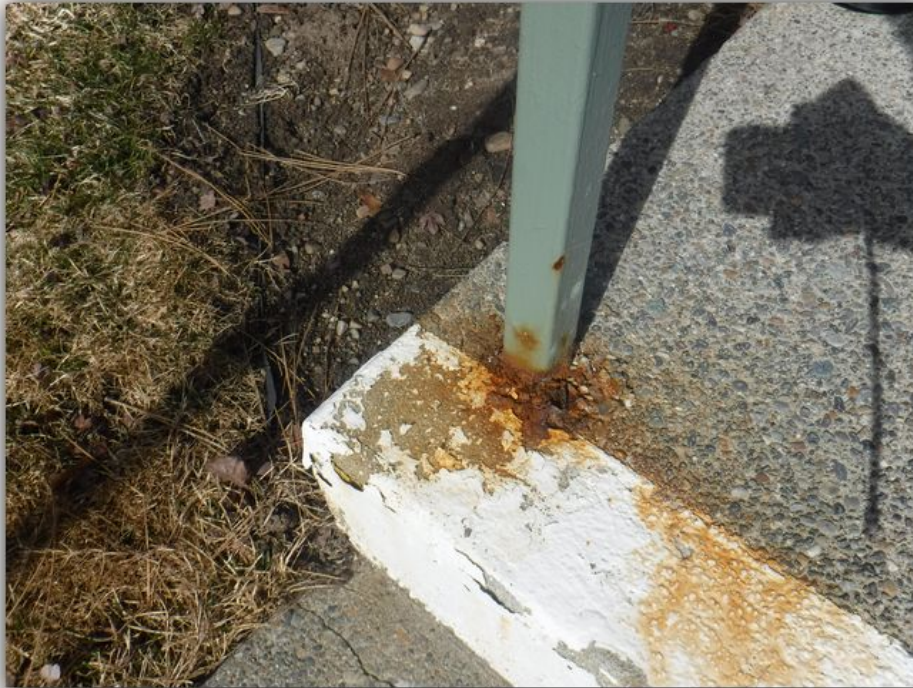
7

Handrail corrosion

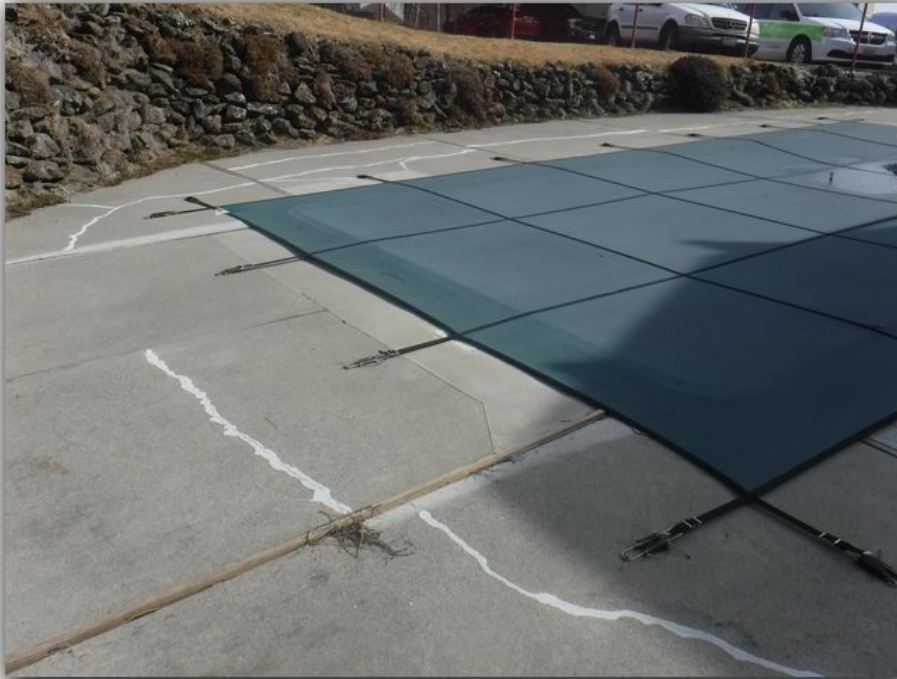
8

Pool deck cracking and settling

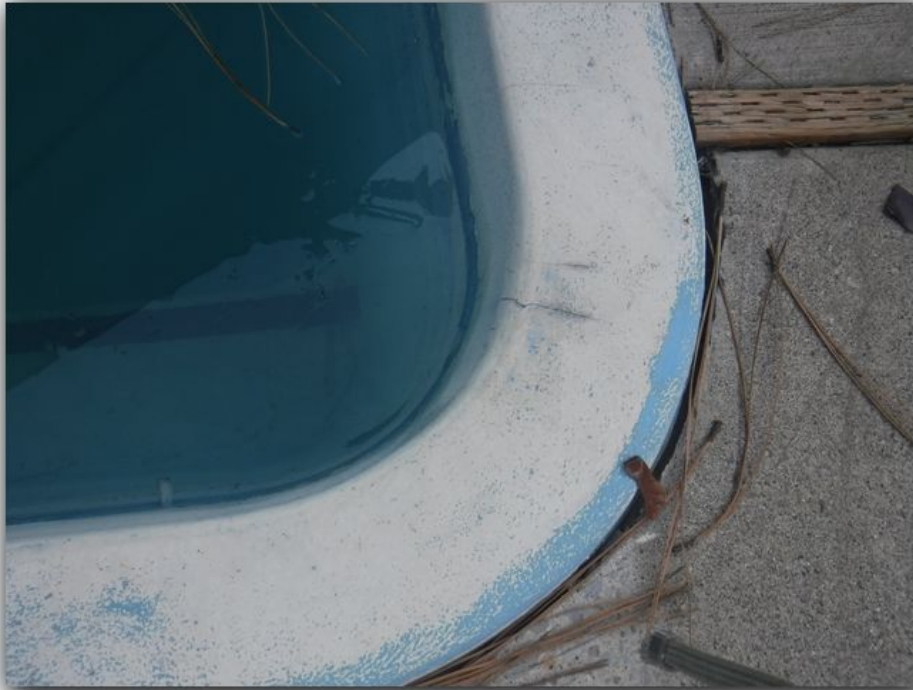
9

Fiberglass surface crack

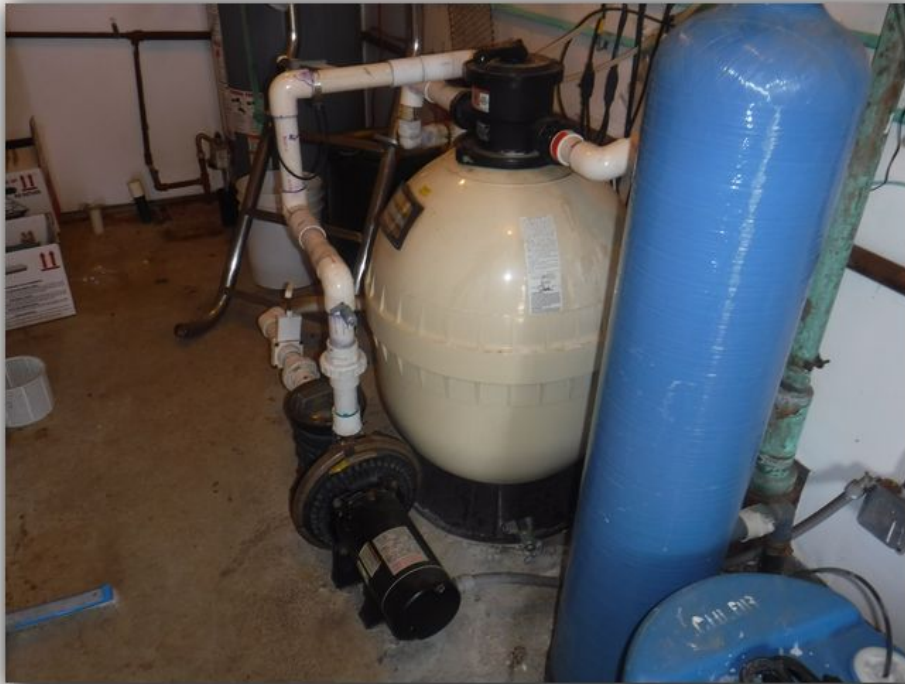
10

Pool equipment

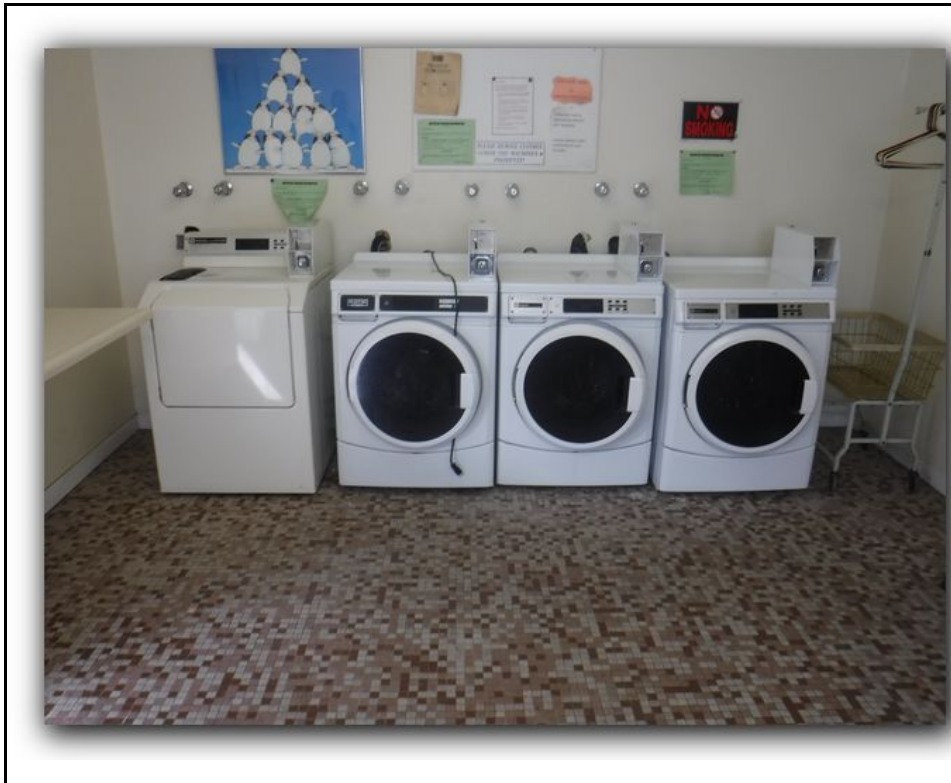
11

Washing machines

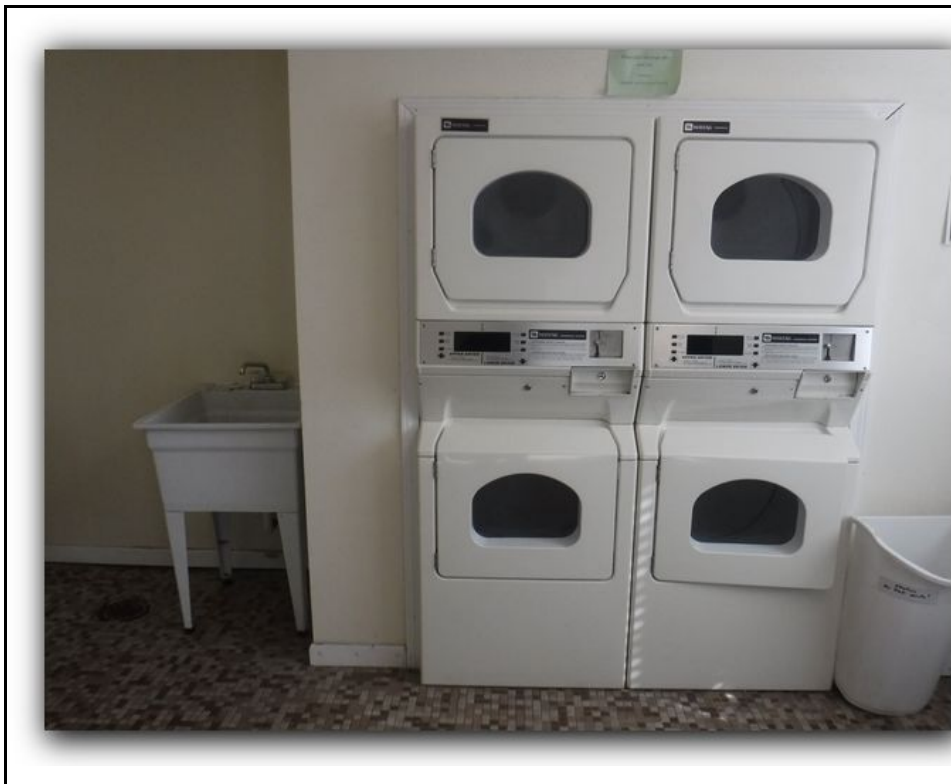
12

Dryers

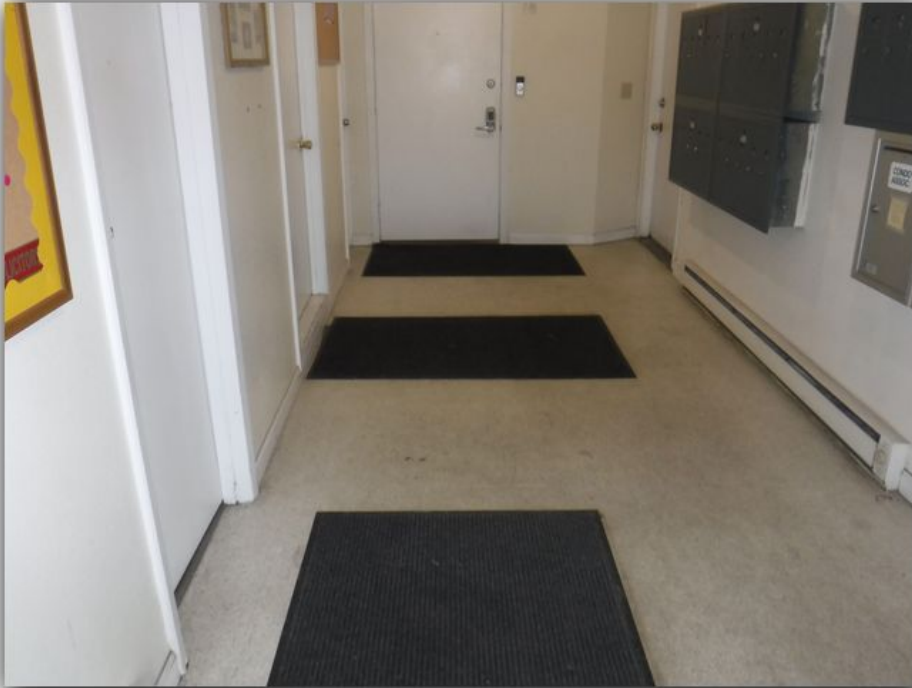
13

Clubhouse hallway

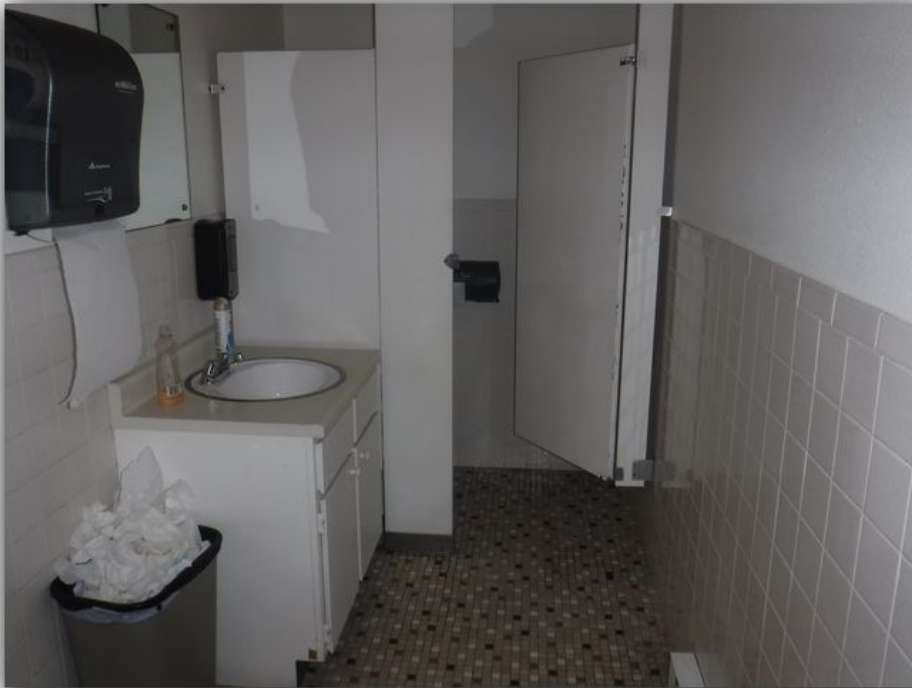
14

Clubhouse restroom

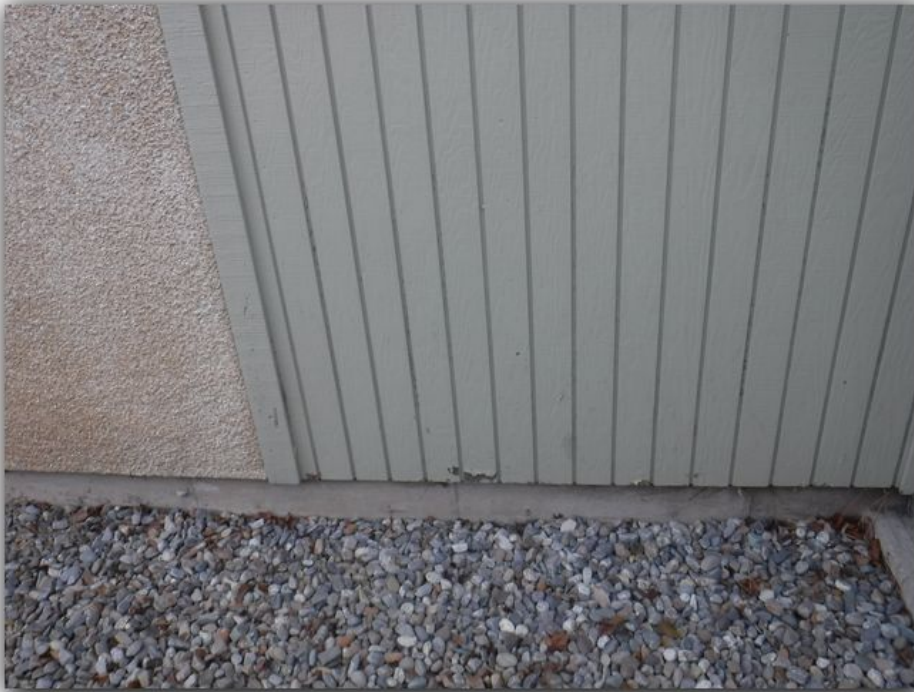
15

North side paint peeling at dripline

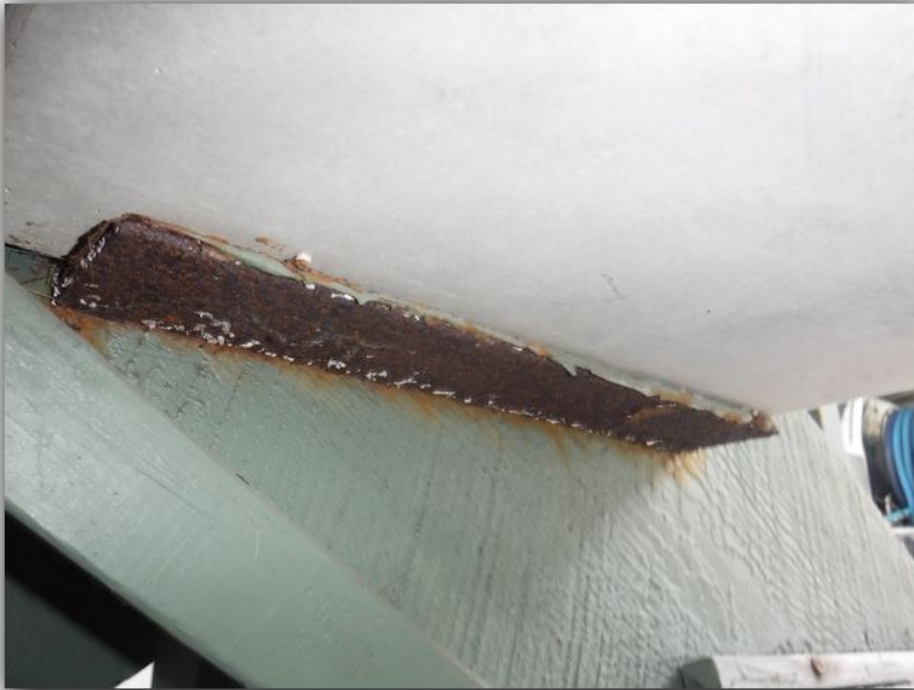
16

Corrosion of stair tread brackets

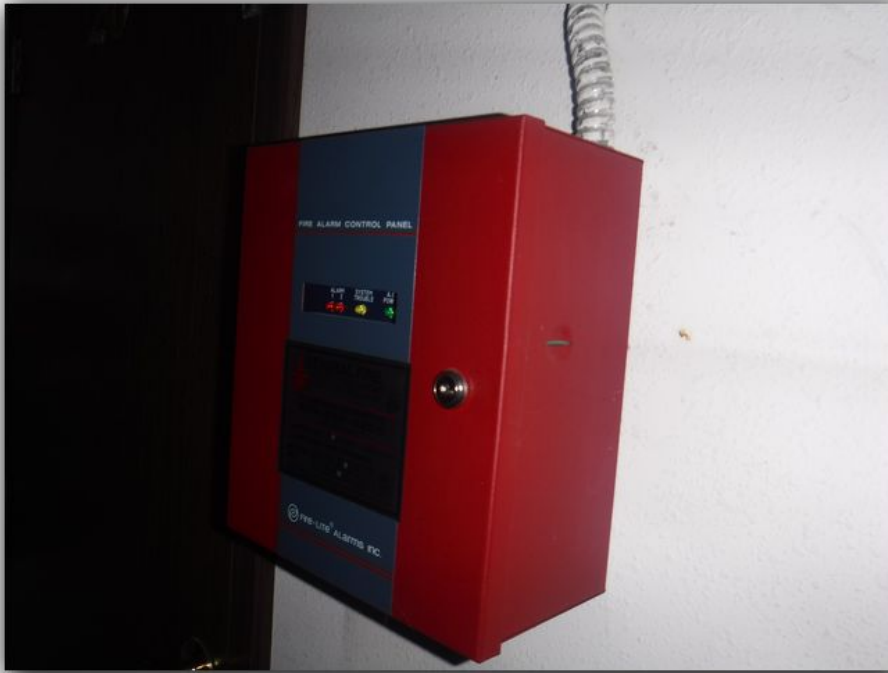
17

Fire panel

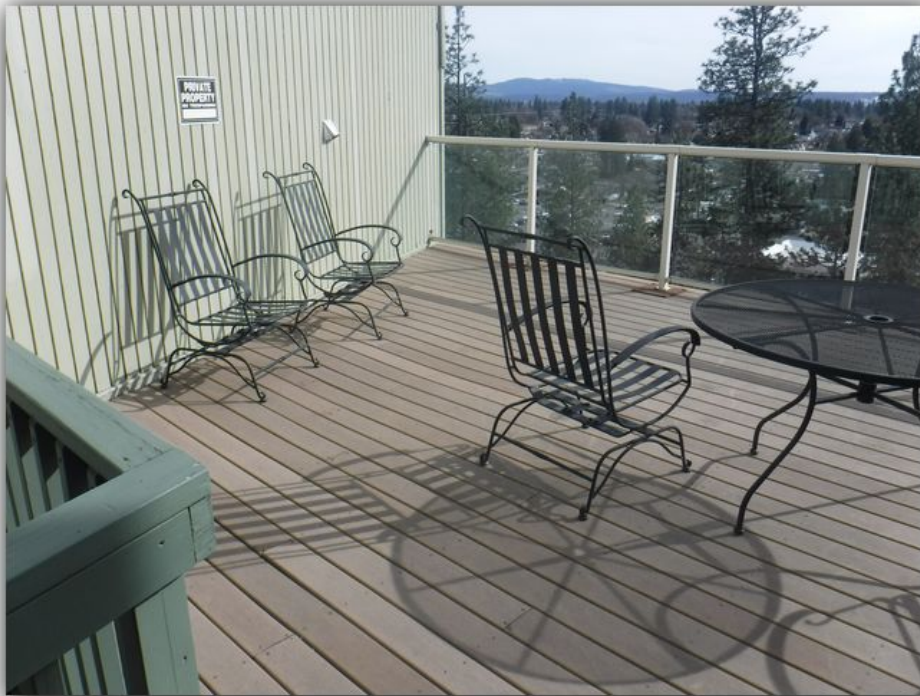
18

Sundeck

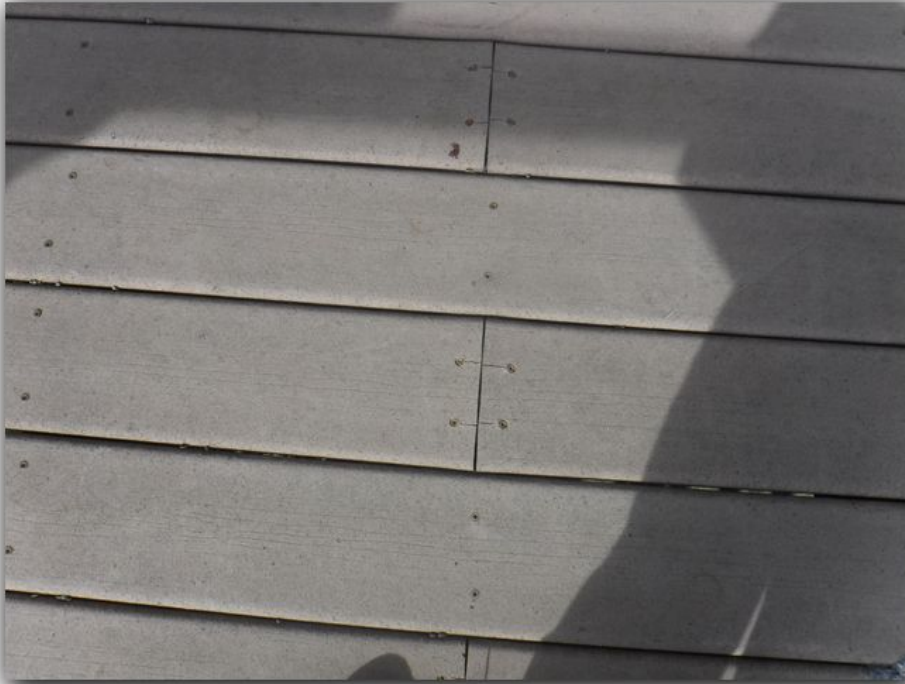
19

Cracks at composite deck screws

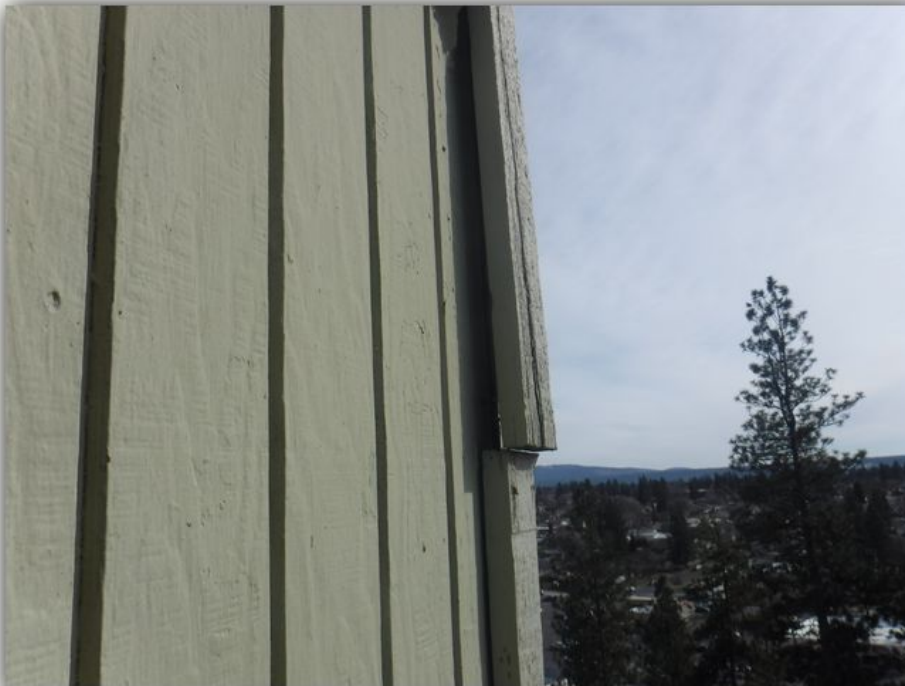
20

Loose and weathered trim board

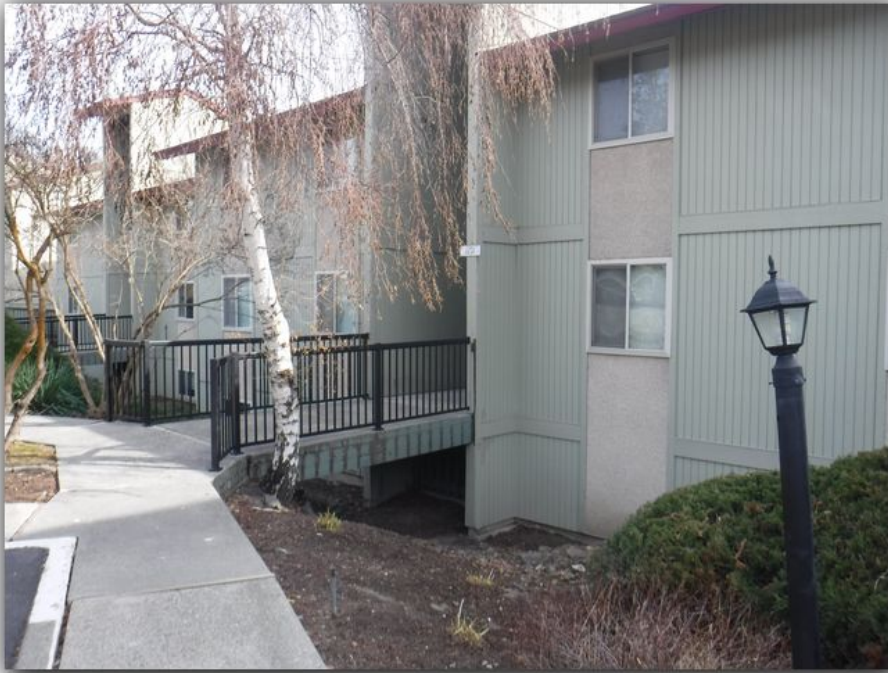
21

Entry bridge

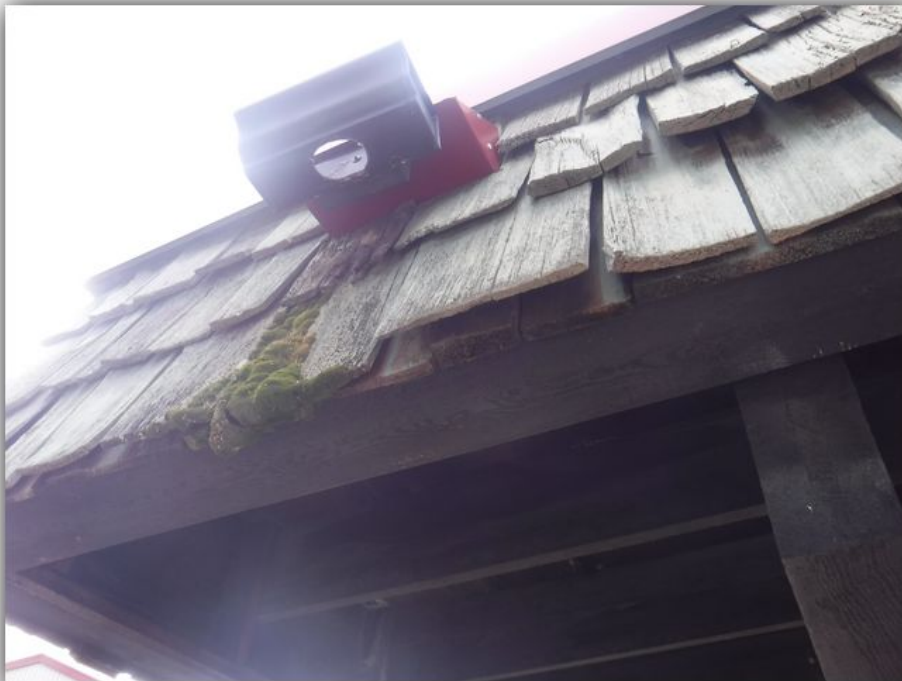
22

Disconnected carport roof drain

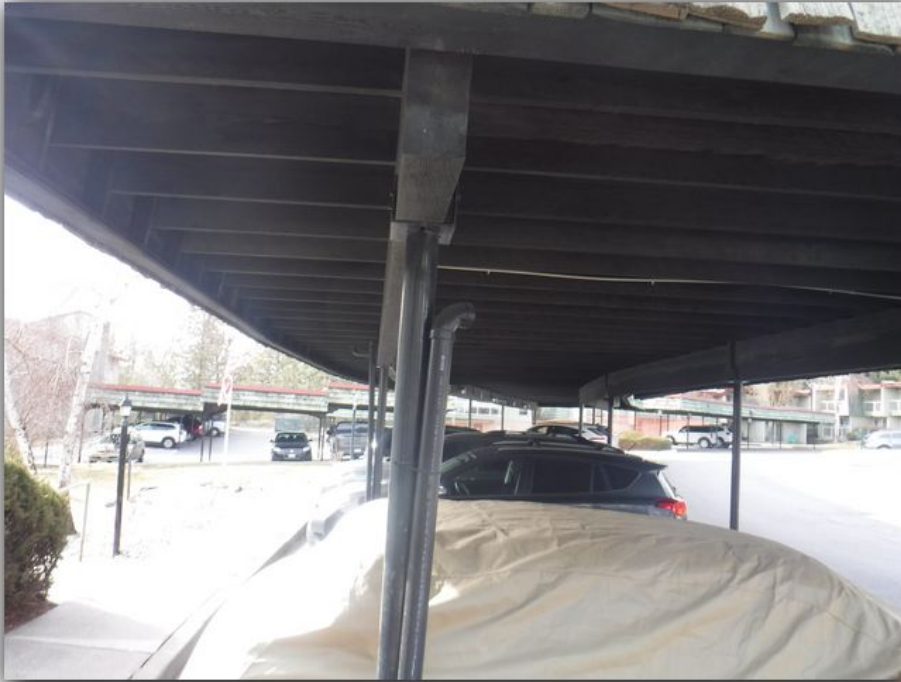
23

Typical carport structure

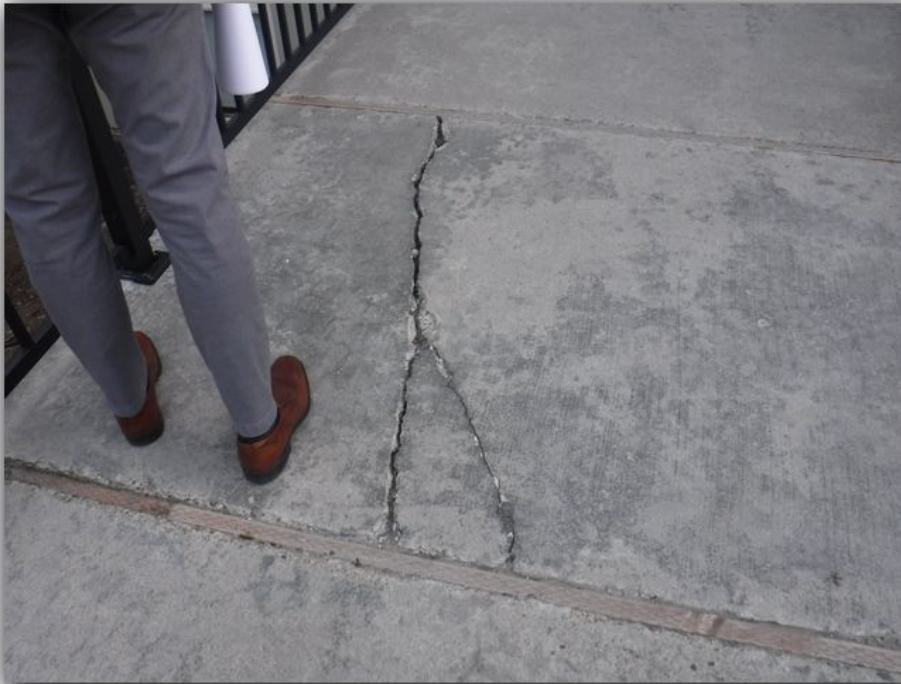
24

Broken slab at building 2

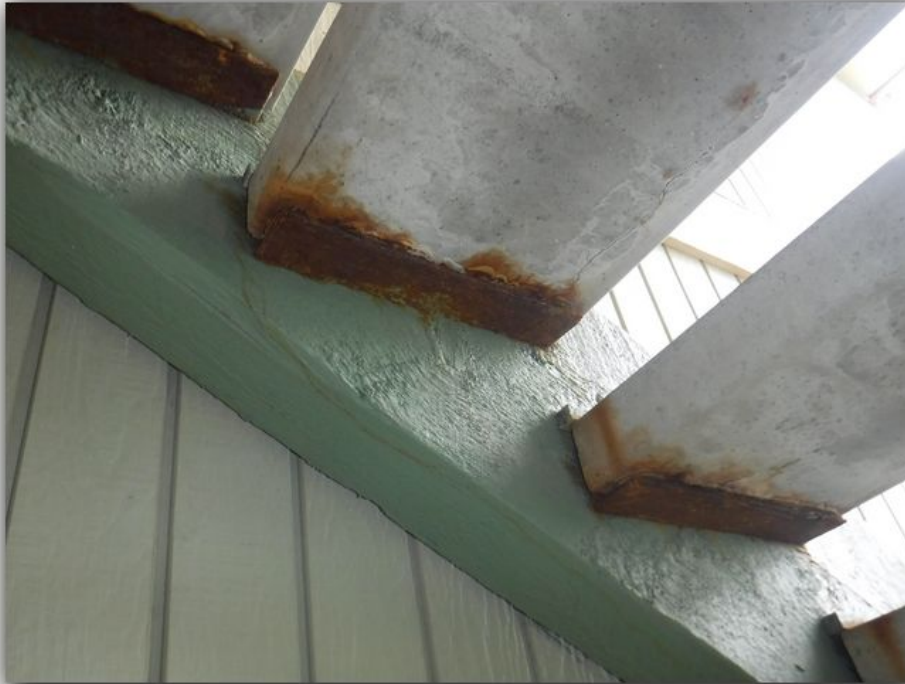
25

Stair tread bracket corrosion

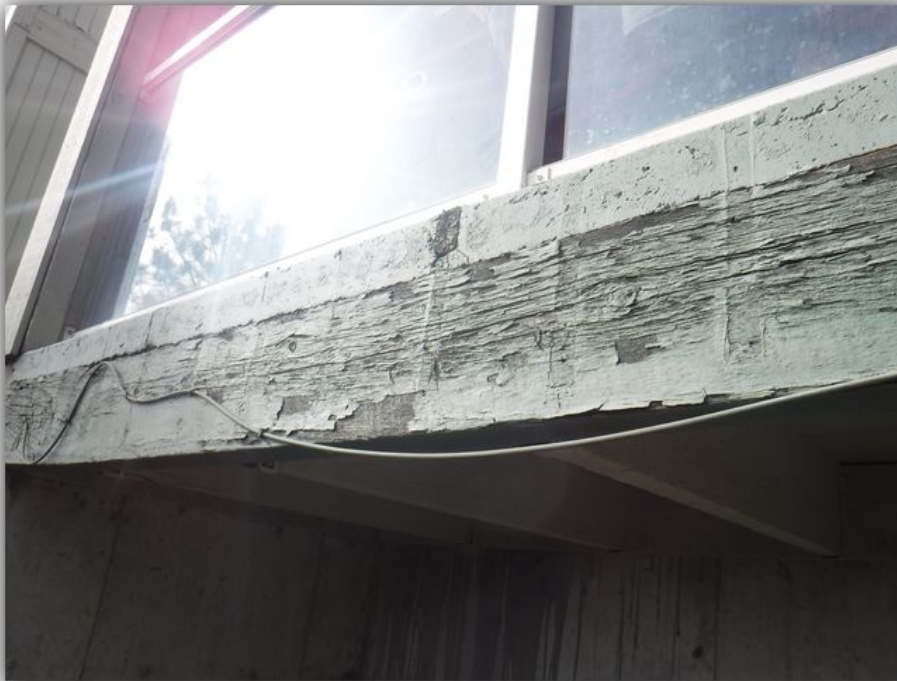
26

Weathered deck rim joist

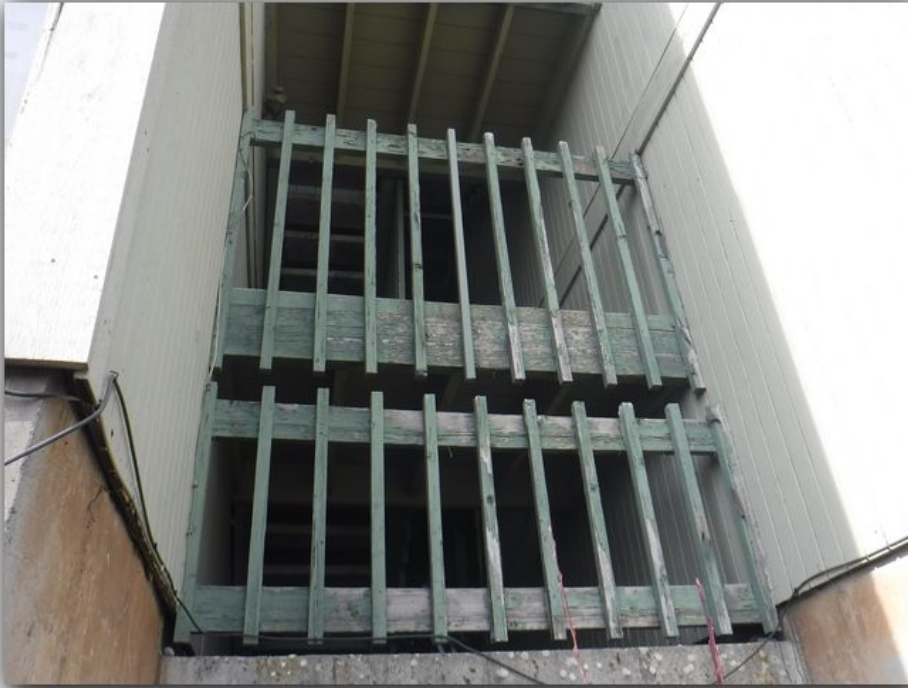
27

Weathered railing and rim joists

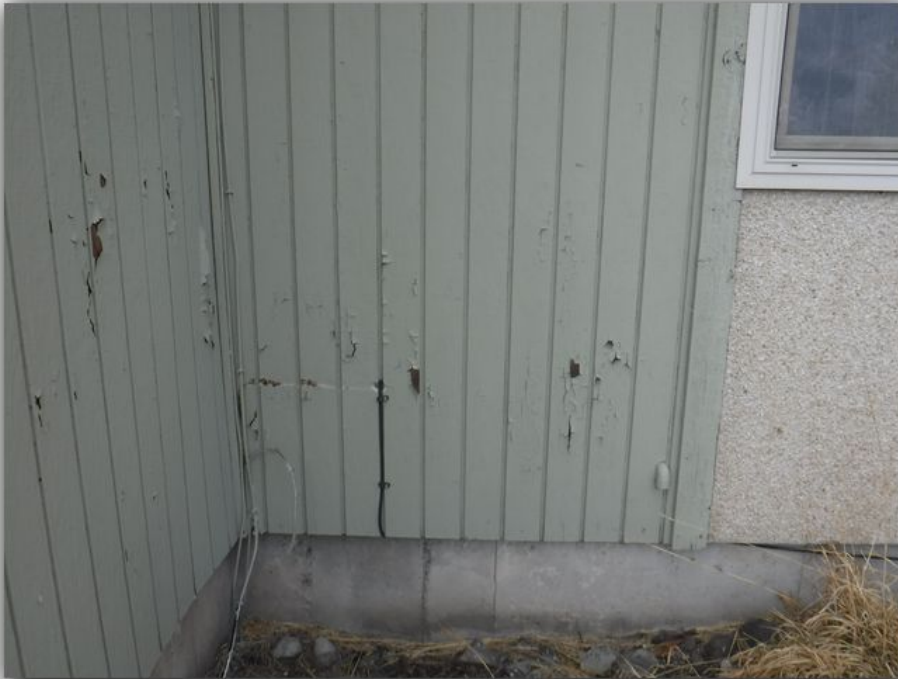
28

Weathered paint

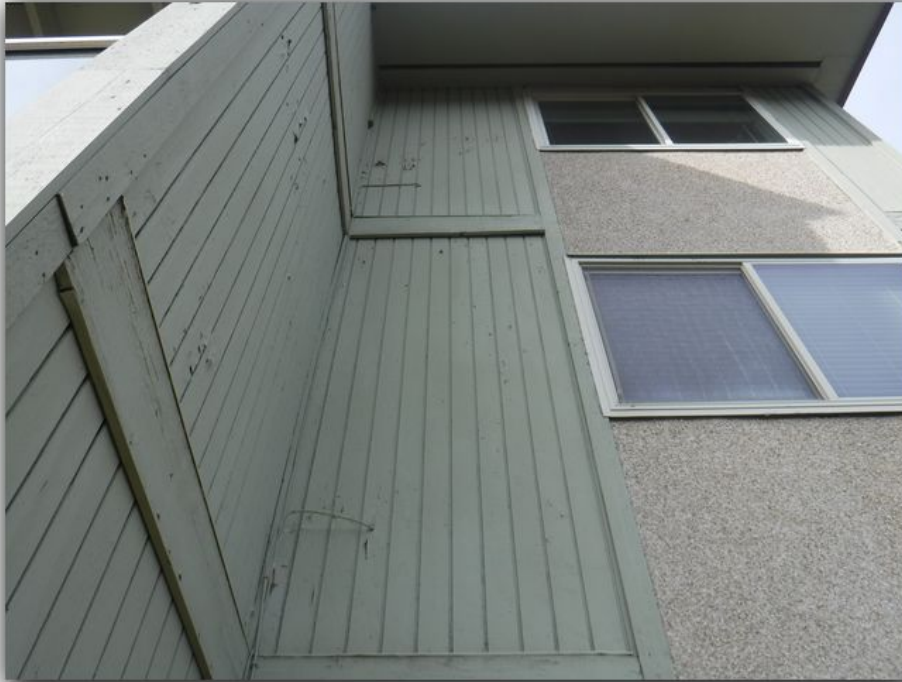
29

Weathered paint

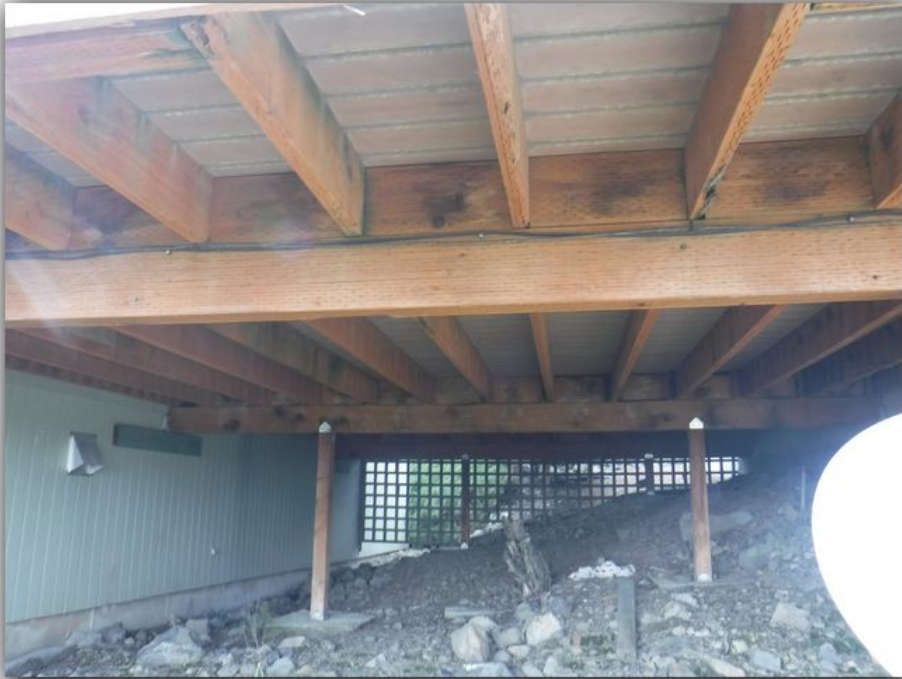
30

Sun deck structure

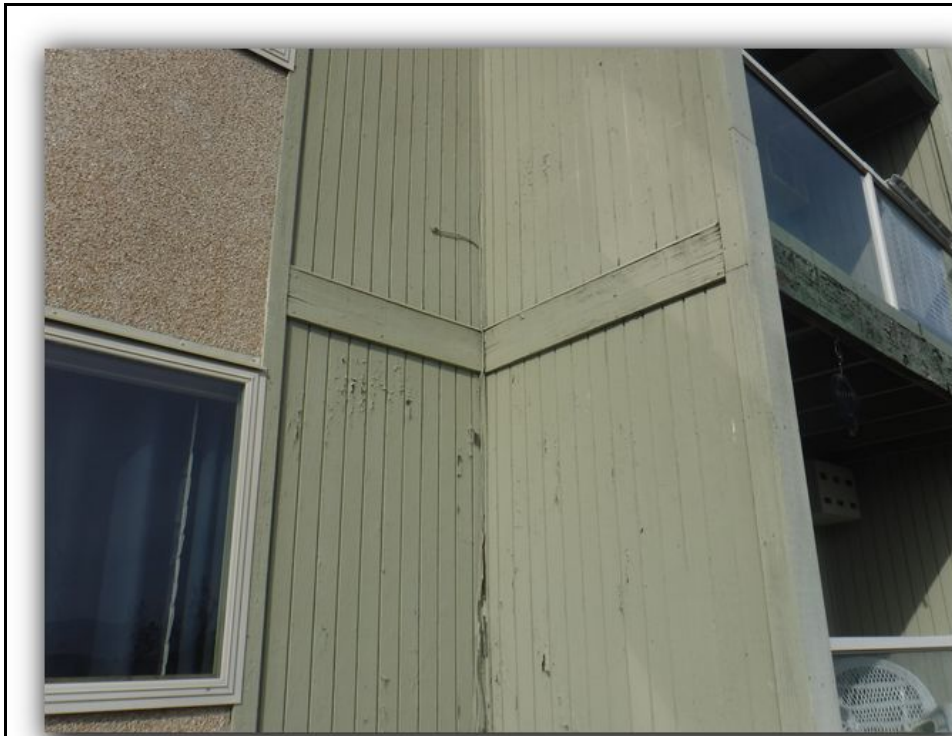
31

Weathered paint

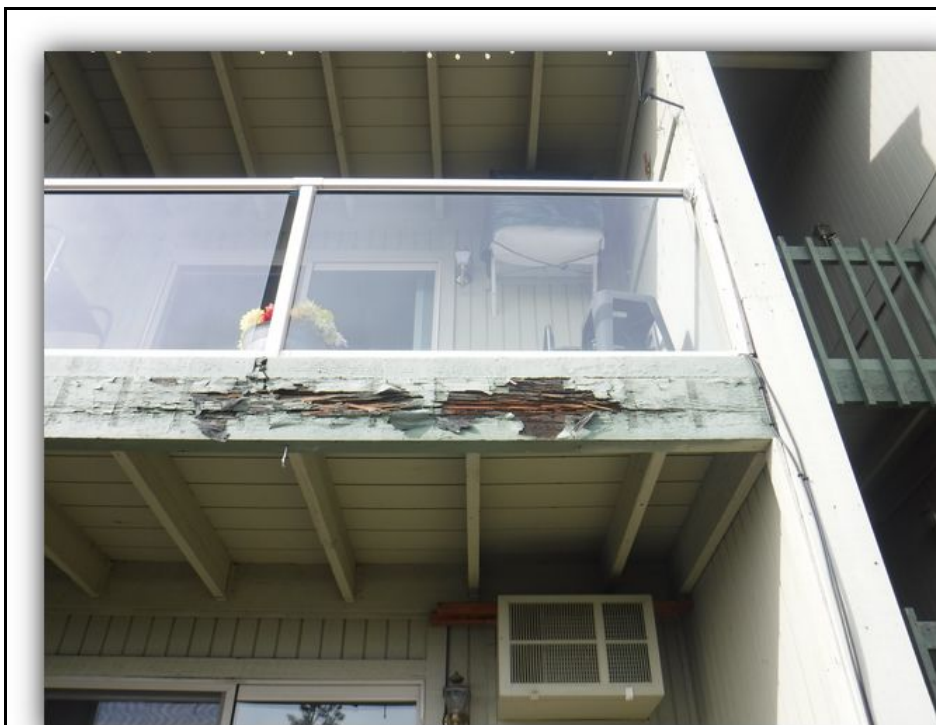
32

Rotted deck rim joist

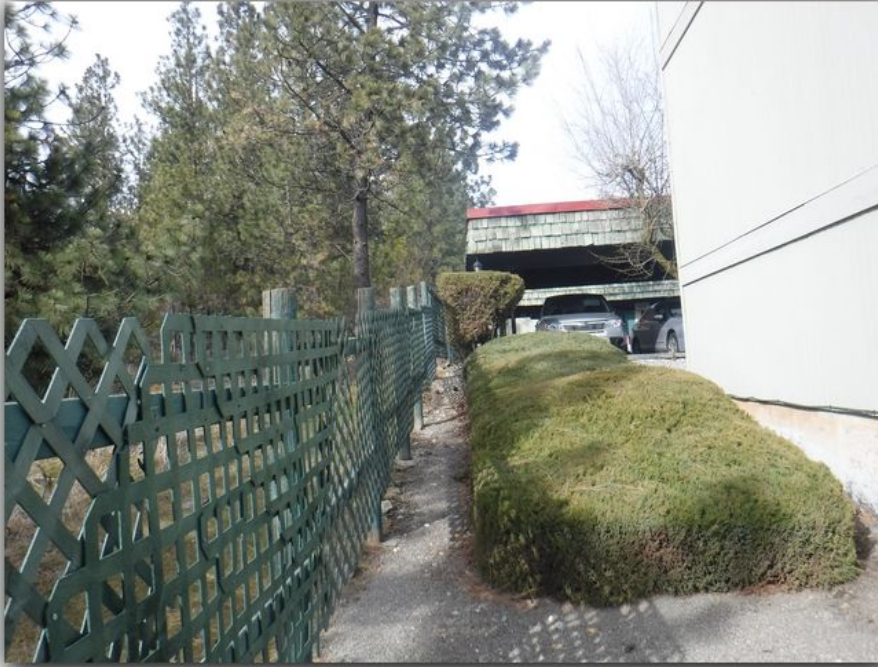
33

Wood fence

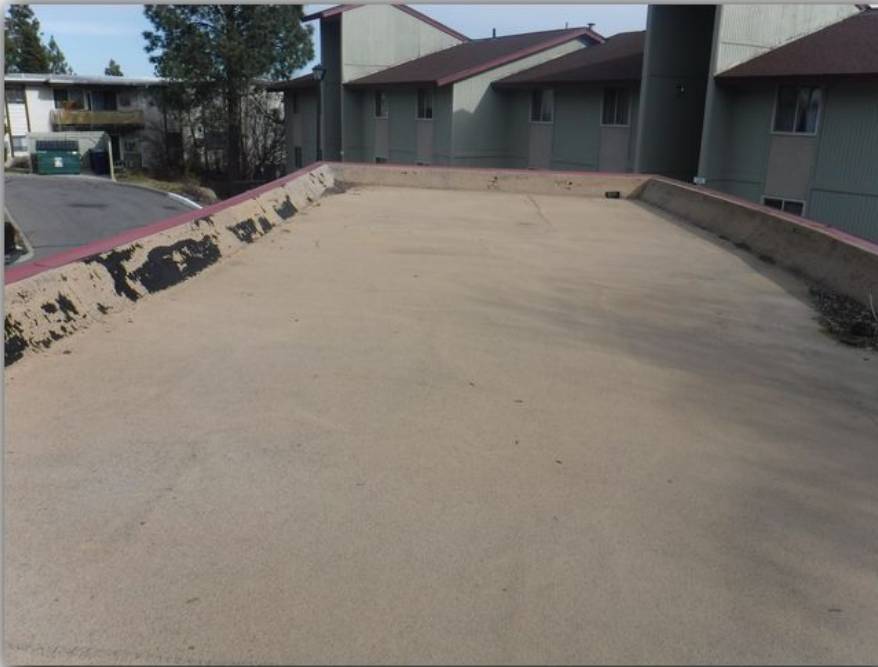
34

Carport roof

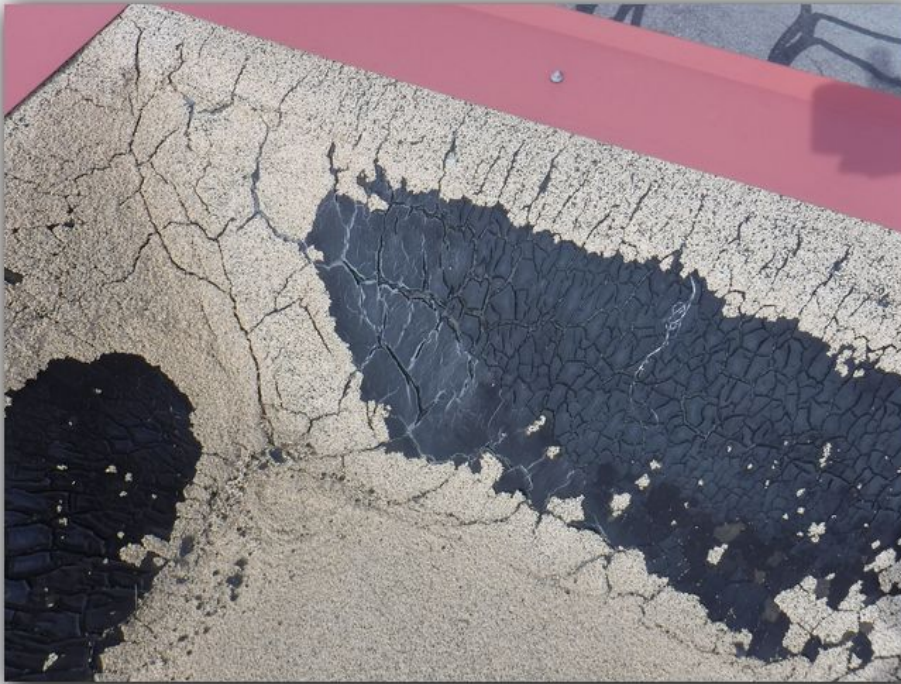
35

Carport roof "alligating"

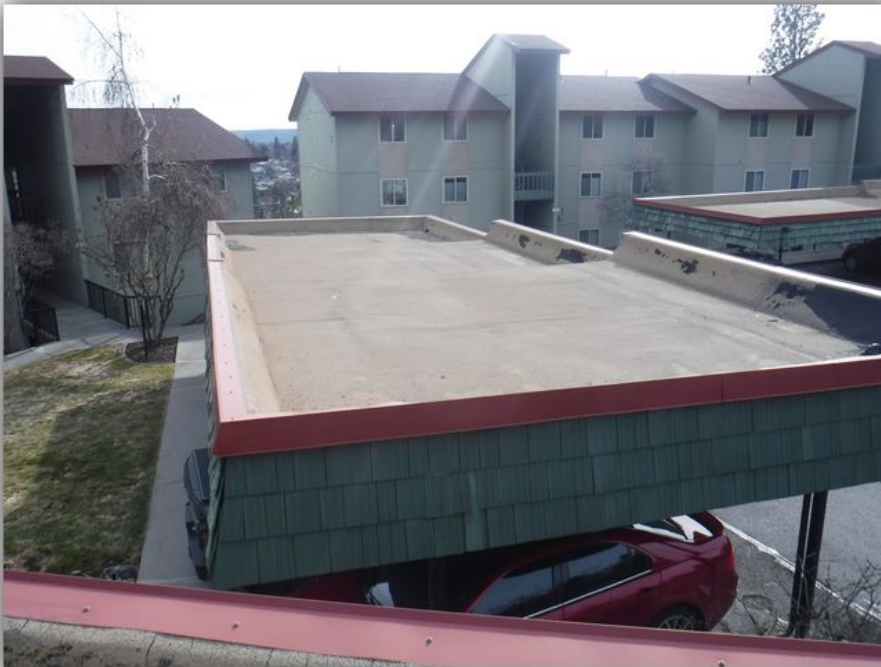
36

Carport roof
